MARINA EL-ALAMEIN

THE CONSERVATION SEASON IN 2002

Stanisław Medeksza

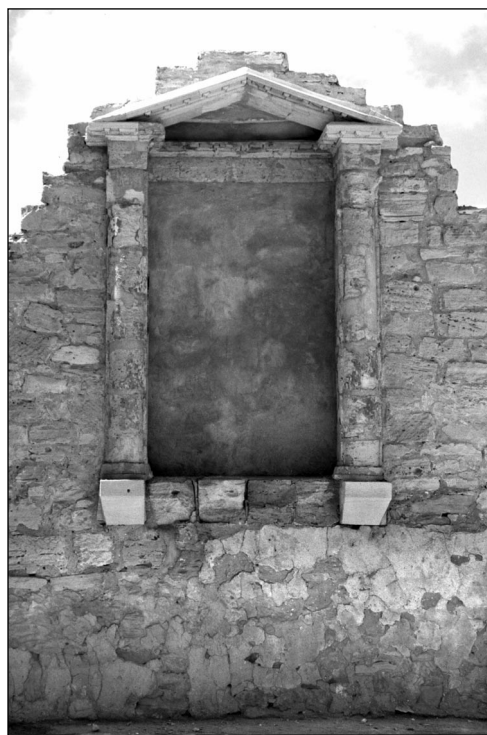
Fig. 2. The niche in room 2 of House 10. After reconstruction of the tympanum (Photo S. Medeksza)

In House H 10, apart from reinforcing the columns of the peristyle, some maintenance protection treatment had to be carried out on wall tops and joints. The key task of the season was the completion of an architectural aedicule, work on which had been ongoing since 1999.⁴⁾ The shafts of the side columns, the architraves and cornices had all been reassembled and reconstructed in the earlier seasons, and work had proceeded on a partial reconstruction of the tympanum.⁵⁾ Some 40% of the two decorated slabs constituting it had to be carved anew and set in their original positions, but using stainless steel dowels in addition to the original stone recesses to support the lower edges (*Fig. 2*).

Tympanum elements of the aedicule from H 10. Conservation followed the same basic procedure as in the case of the above-described aedicule and resulted in a remounting of the preserved fragments in their original position crowning the niche in room 2 of house H 10. The stainless steel dowels (□12 mm) that were used were 28 cm long and were spaced symmetrically on both sides of the tympanum base.

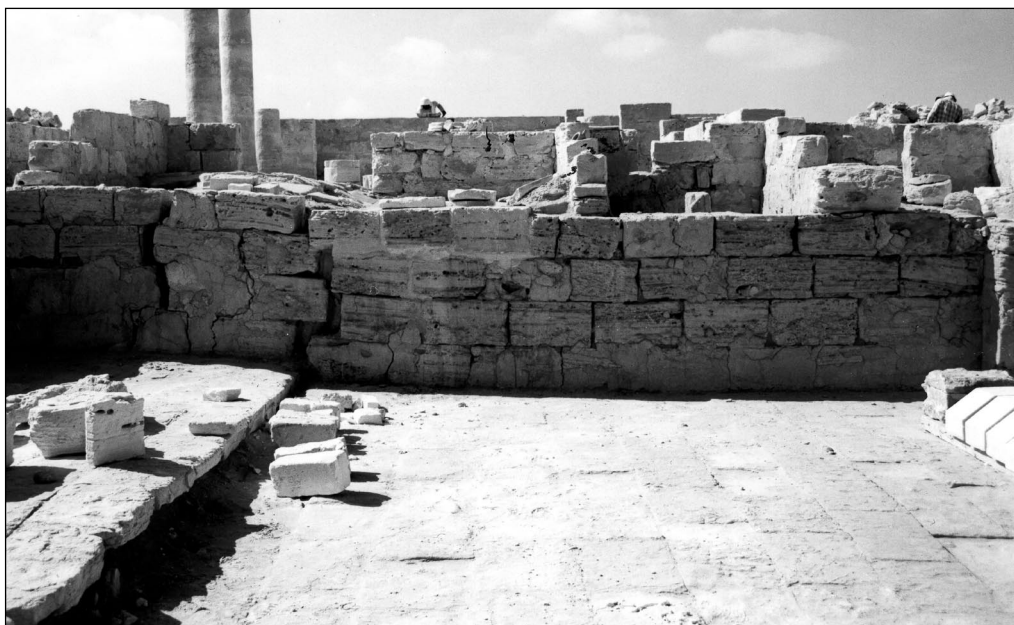
The hall H 21“N” incurred heavy damages due to earth subsidence, possibly in effect of an earthquake. The walls had cracked and slipped and a large section of the floor had settled (*Fig. 5a*). Restoration of the original form would have been extremely difficult and would have entailed a virtual rebuilding of the hall from scratch. It was deemed unnecessary and the preservation was limited to a structural reinforcing of the walls and floor with additional masonry. The crack in the floor and subsiding of the western two thirds of the hall can be seen also in rooms 10 and 1 of house H 21c abutting the hall on the south. Again, this difference in levels was kept. The walls were built up, especially the northeastern and northwestern corners, to a height of 1.20 m for the corners and 1.00 m for the walls. The cracks in the

Fig. 5a. Hall H 21 "N". Before conservation. Close-up view from the north of the cracked south wall and displaced pavement (Photo S. Medeksza)

walls were filled with masonry, but recessed with regard to the original wall face. For the walls, original stone blocks were used bonded in lime mortar mixed with some white cement.

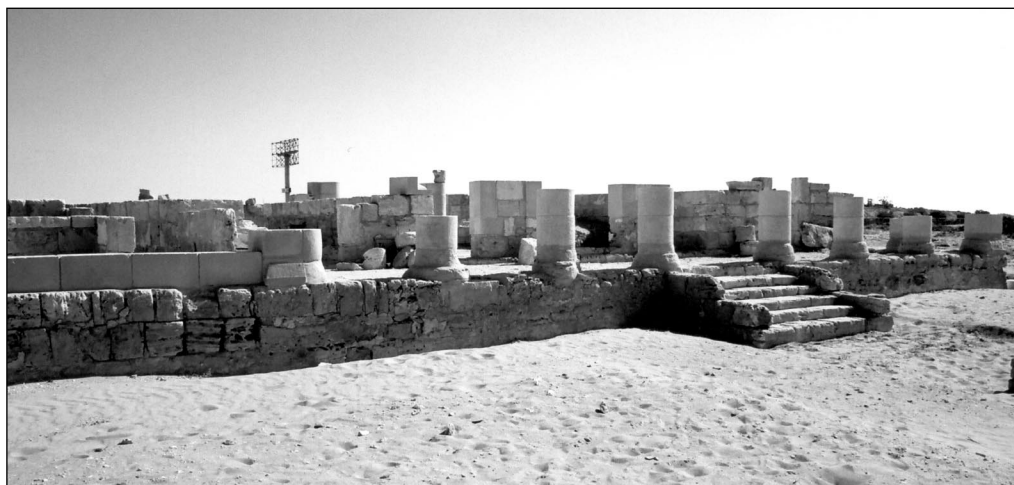
Fig. 6. Façade of the mausoleum of Tomb 6 after reconstruction in 2002. View from the northeast (Photo S. Medeksza)

In the course of the 2002 season several column drums were reconstructed of Helwan limestone, the objective being to recreate the rhythm of columns in the front portico. The two columns flanking the

main entrance were built up to a height of 1.15 m, while the remaining columns were made to be from 0.95 to 0.76 m high. The lime mortar used for the bonding included some white cement. No dowels were used as *anathyrosis* of the sections afforded sufficient adherence of the elements.

Landscaping around the tomb (done by the archaeological mission earlier in the season) was intended to make the facade of the monument better visible from the tourist route (*Fig. 6*).
